**Expert Report of  
Timothy Myers, Ph.D., CFEI**

**Marcellin, et al. v. HP, Inc. and Staples, Inc.**

**December 2, 2024**

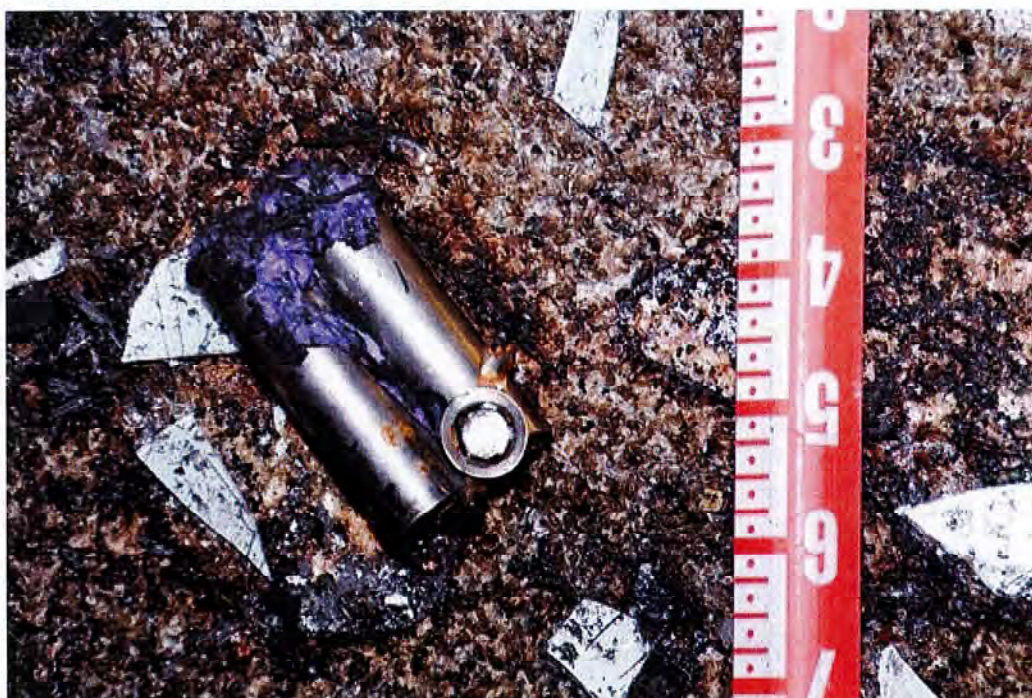
Figure 34 shows a photograph of Cells 1 and 2, which were found on the ground close to the notebook area. As highlighted in Dr. Quinn Horn's Expert Report, these cells did not go into thermal runaway; large portions of the wrapper were still adhered to the cells, the cells were still tapped, and based on the limited X-ray imaging available for review, the cells appeared to have almost entirely intact electrodes internally. Because Cells 1 and 2 did not go into thermal runaway, they can be ruled out as potential ignition sources.

Figure 34. Photograph of the two cells (Cells 1 and 2) found on the office carpet in front of the incident notebook that did not go into thermal runaway.<sup>98</sup>

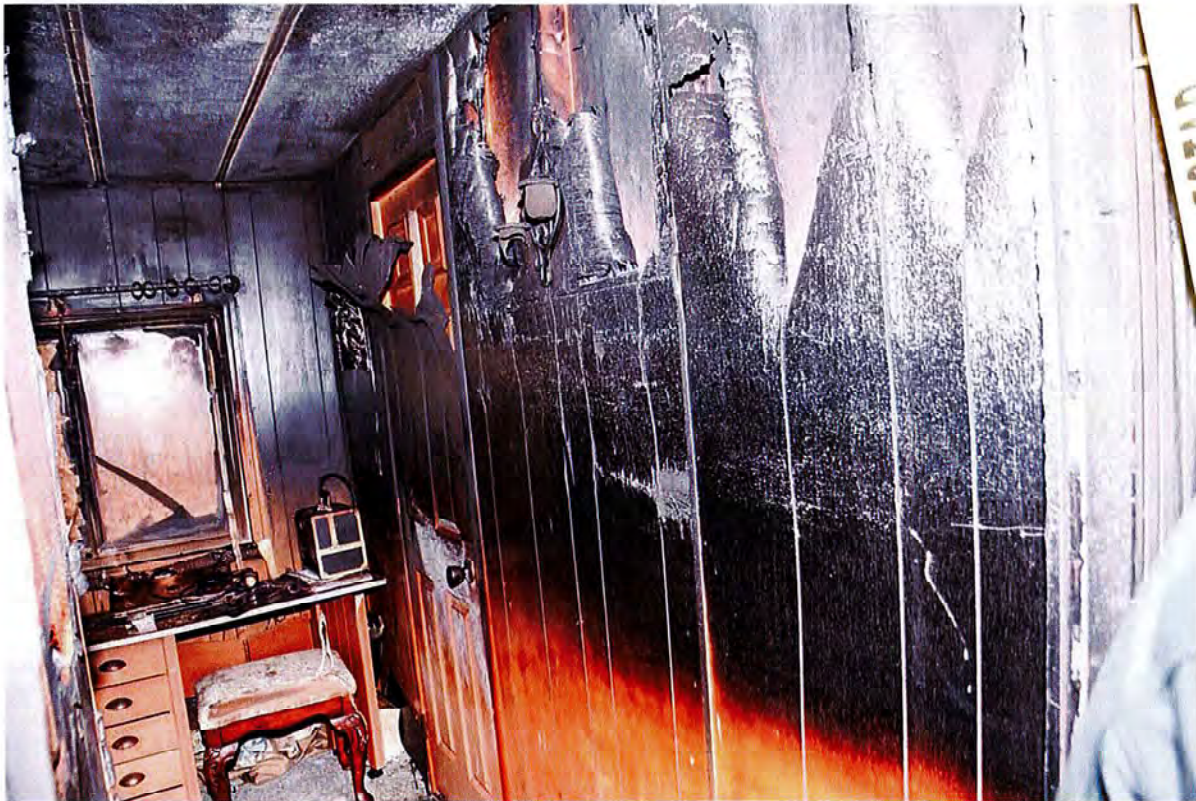
Figure 38. Photograph on candle sconces on office wall.
